## WHIPPLE SUPERCHARGERS BILLET THROTTLE BODY ADJUSTMENT FORD S550/F150 5.0L 2015-2017

Due to factory variances on the electronic throttle cover, some adjustment may be required.

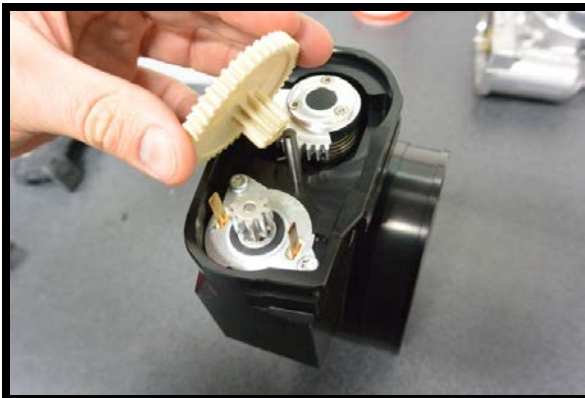
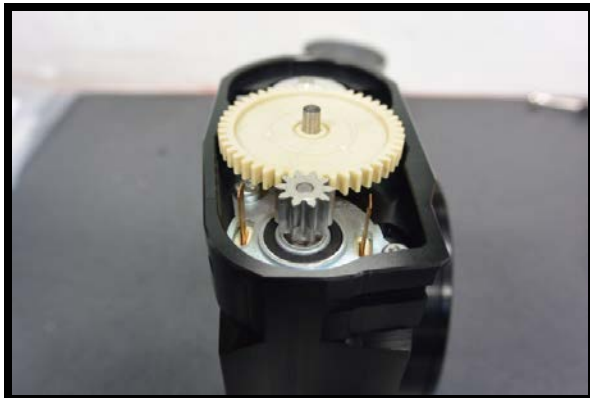
1. Remove the factory plastic gear to the throttle body by lifting up and away.

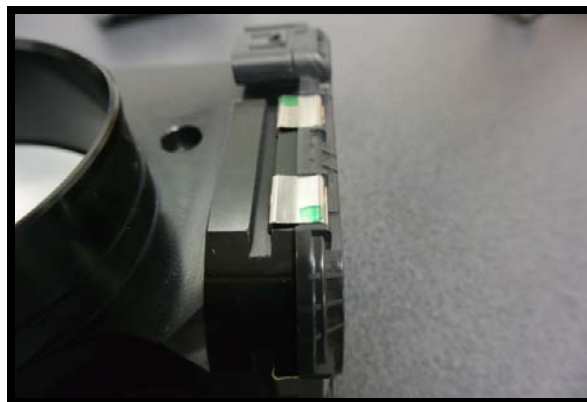
2. Remove the (6) throttle body cover tabs by releasing using a small pick or screw driver.

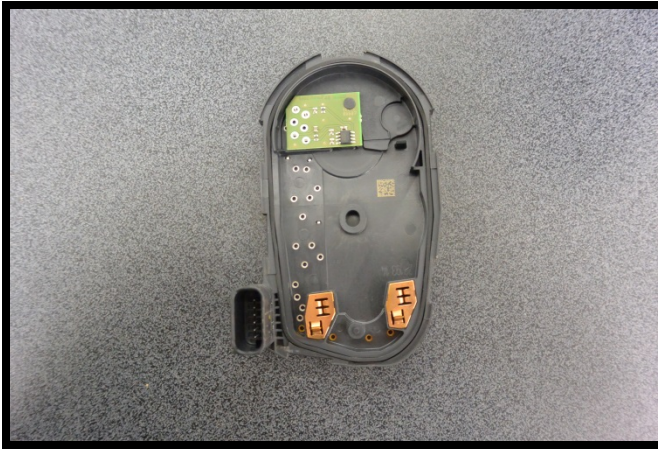
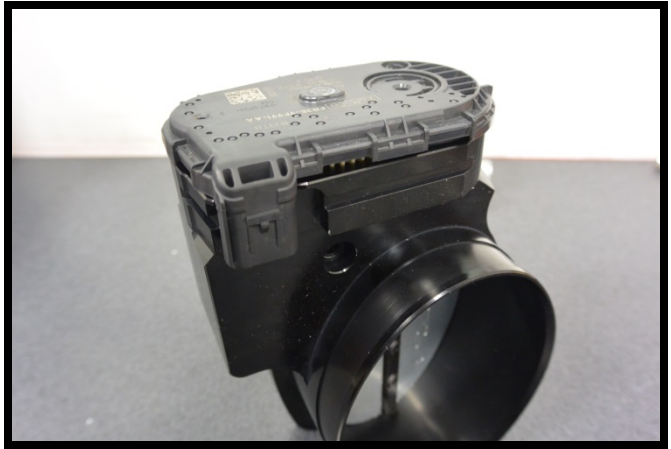
3. Remove the factory cover for access to the magnet and the (3) socket head allen bolts securing it.

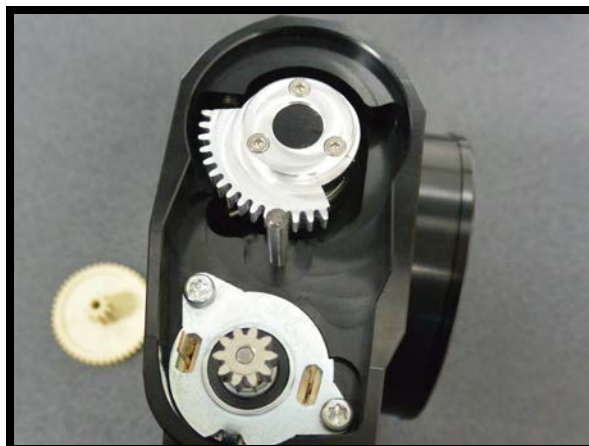
4. Its always good to make a mark using a white out or grease pencil on the magnet and billet gear for reference before adjustment. Using a 2.5mm allen socket, carefully loosen the (3) bolts, do not remove. Carefully move the black magnet clockwise to increase voltage, counter clockwise to lower (extremely small adjustments). Lightly tighten the bolts after movement, install the cover without tabs, push the blade to max closed position for accurate reading and recheck TPS2 (most improtant reading). Repeat until the unit is in the (.40v - .045v) range at max closed position.

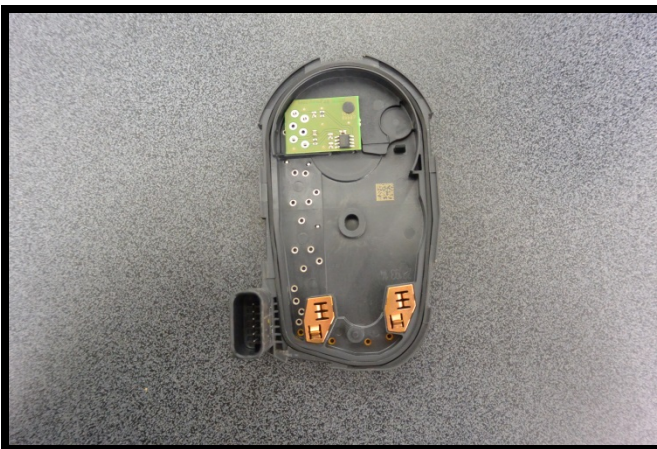
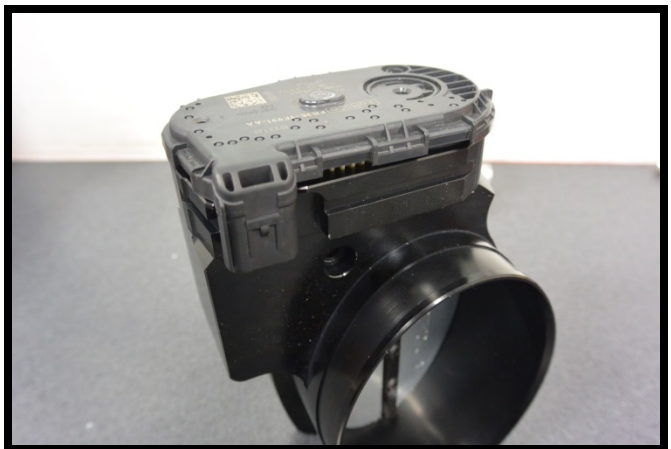
6. Reinstall the factory cover, make sure the oring stays in place during assembly and the (2) electrical connections are made.

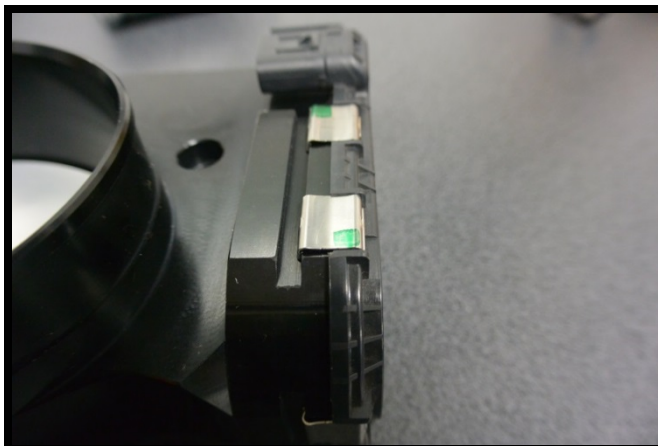
7. Reuse the (6) throttle body cover tabs by pressing on until they click and lock in place.
